Manhole Inspection Summary

Manhole # S49EE_008MH

Insp Date: **7/13/08 11:13 AM**

Location Address: **MILTON ST**

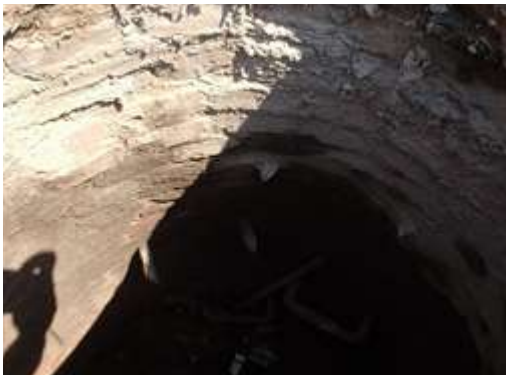
Defect 1

Chimney / Frame Adjustment ☒ Exists Material: **Brick** ☐ Parged Height: **6** (in.)
Condition: ☒ Sound ☐ Cracked ☐ Root Intrusion ☐ Loose Brick ☐ Deteriorated
Infiltration: ☐ None ☒ **Joint** ☐ Cracks ☐ Mortar ☐ Roots ☒ **Wall**

Corbel Material: **Brick** ☐ Parged Type: **Concentric/Eccentric**
Condition: ☒ Sound ☐ Cracked ☐ Root Intrusion ☐ Loose Brick ☐ Deteriorated
Infiltration: ☐ None ☐ Joint ☐ Cracks ☐ Mortar ☐ Roots ☒ **Wall**

Barrel Material: **Brick** ☐ Parged
Shape: **Circular** Diameter: **42** (in.) Length: (in.)
Condition: ☒ Sound ☐ Cracked ☐ Root Intrusion ☐ Loose Brick ☐ Deteriorated
Infiltration: ☐ None ☐ Joint ☐ Cracks ☐ Mortar ☐ Roots ☒ **Wall**

infiltration

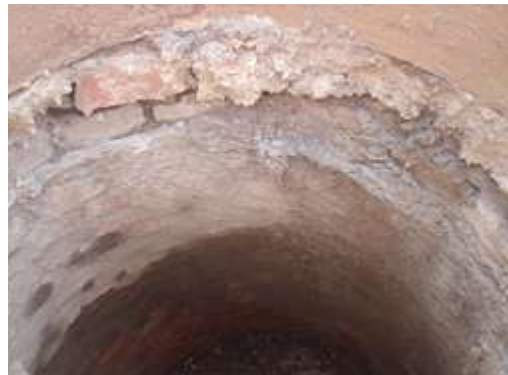
Defect 2

Frame Offset: **2** (in.) Condition: ☐ Sound ☐ Cracked ☒ **Leaks**

frame leaks

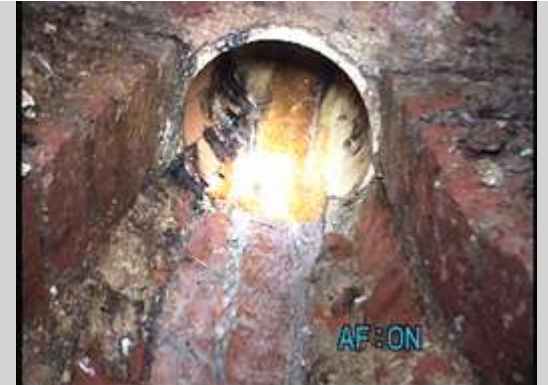
12 O'Clock Outflow

8 in. Circular Gravity Sewer
Pipe Out @ 12 O'Clock

Pipe Height: **8.4** (in.) Rod and Bar (Angled)
Pipe Material: **Clay** ☐ Pipe Lined
Invert Depth: **8.70** (ft.) Flow Characteristics: **Fast**
Deposits: ☒ None ☐ Mud ☐ Sludge ☐ Debris ☐ Grease
Silt Depth: (in.) Deposits Extent:
Infiltration: **None** Pipe Seal Cond: **Sound**

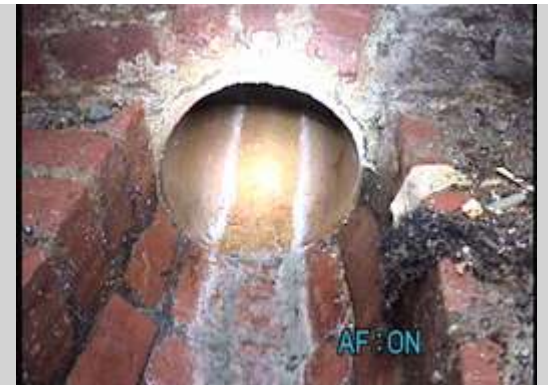
3 O'Clock Inflow

8 in. Circular Gravity Sewer
Pipe In @ 3 O'Clock

Pipe Height: **8.4** (in.) Rod and Bar (Angled)
Pipe Material: **Clay** ☐ Pipe Lined
Invert Depth: **8.50** (ft.) Flow Characteristics: **Fast**
Deposits: ☒ None ☐ Mud ☐ Sludge ☐ Debris ☐ Grease
Silt Depth: (in.) Deposits Extent:
Infiltration: **None** Pipe Seal Cond: **Sound**
